Manhole Inspection Summary

Manhole # S21C__036MH

Insp Date: **10/17/07 11:30 AM**

Location Address: **1902 LAURETTA-FRANKLIN**

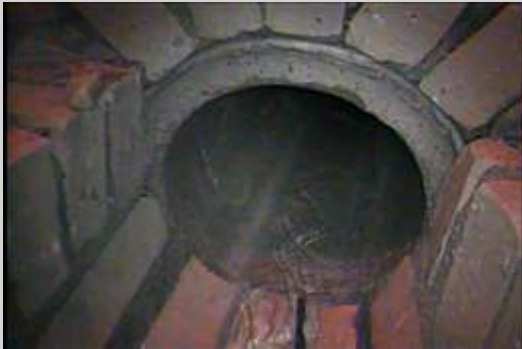
12 O'Clock Outflow

8 in. Circular Gravity Sewer
Pipe Out @ 12 O'Clock

Pipe Height: **8.4** (in.) Rod and Bar (Angled)
Pipe Material: **Clay** ☐ Pipe Lined
Invert Depth: **7.92** (ft.) Flow Characteristics: **Slow**
Deposits: ☒ None ☐ Mud ☐ Sludge ☐ Debris ☐ Grease
Silt Depth: (in.) Deposits Extent:
Infiltration: **None** Pipe Seal Cond: **Sound**

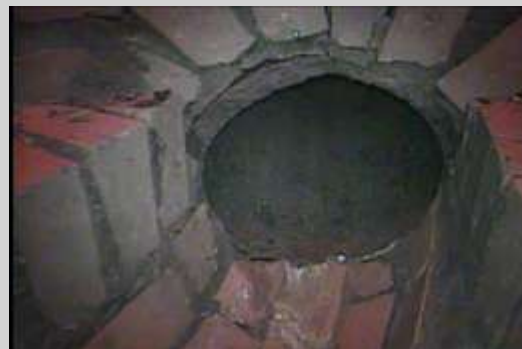
Drop In @ 3 O'Clock

Drop: **Outside** Rod and Bar
Angled: **Yes** Reading: **6.94** (ft.)
Inv Depth: **7.94** (ft.)
Drop Condition: **Open**
